Submitted to:  
Platte River Power Authority  
Ft. Collins, CO

Submitted by:  
AECOM  
Ft. Collins, CO  
60743633  
January 17, 2025

# Platte River Power Authority Rawhide Station

## Annual Ash Monofill Inspection Report – January 2025

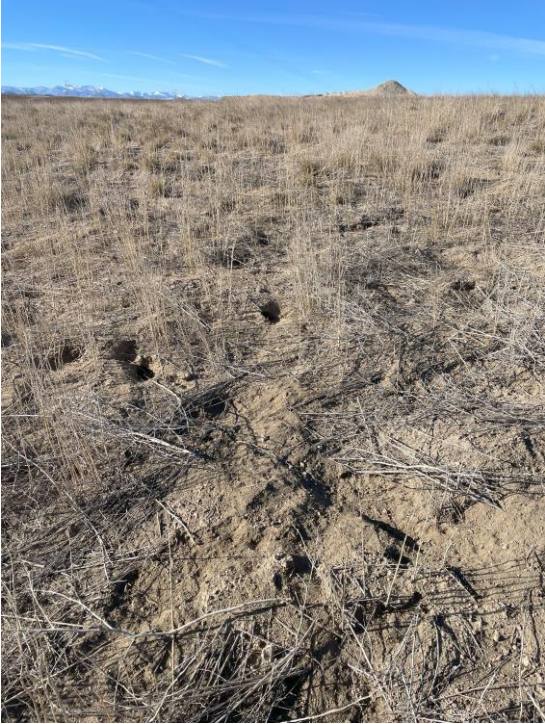
<b>Client Name:</b> Platte River Power Authority		<b>Site Location:</b> Rawhide Station, Wellington, CO	<b>Project No.</b> 60643633
<b>Photo No.</b> <b>1</b>	<b>Date:</b> 12/3/24

- The starter dike at Cell 1 and Cell 2 appeared to be in good condition with occasional small animal burrows (1 to 2-inch diameter) in the upper 8 to 12 inches of the ground surface in isolated areas. The cover slopes of Cell 1 and Cell 2 appear to be in good condition with occasional animal burrows in isolated areas (Photo 1 of **Attachment 8**).
- One large burrow (6- to 8-inch diameter) was observed on the east slope of Cell 1, approximately 15 feet west of the access road in alignment with PRS-02 (Photo 2 of **Attachment 8**). A second large animal burrow (6-8 inches in diameter) was observed at the north end of Cell 1. Additionally, small amounts of exposed ash were observed near the ditch and access road on the east side of Cell 1, approximately 1,000 feet north of the PRS Ponds (Photo 3 of **Attachment 8**). Access roads over the starter dikes and around the monofill

<b>Direction Photo Taken:</b>  Northwest			
<b>Description:</b>  <u>Location:</u> Cells 1 and 2  Occasional small animal burrows on east slope of Cell 1

- The number of small burrow areas observed on Cell 1 does appear to be slightly increasing from previous inspections. Small animal burrows have now been observed in the protective cover of cell 2B and the areas should be monitored. Removal steps are in progress. There does not appear to be erosional concerns surrounding the burrows at this time, but areas should continue to be monitored.

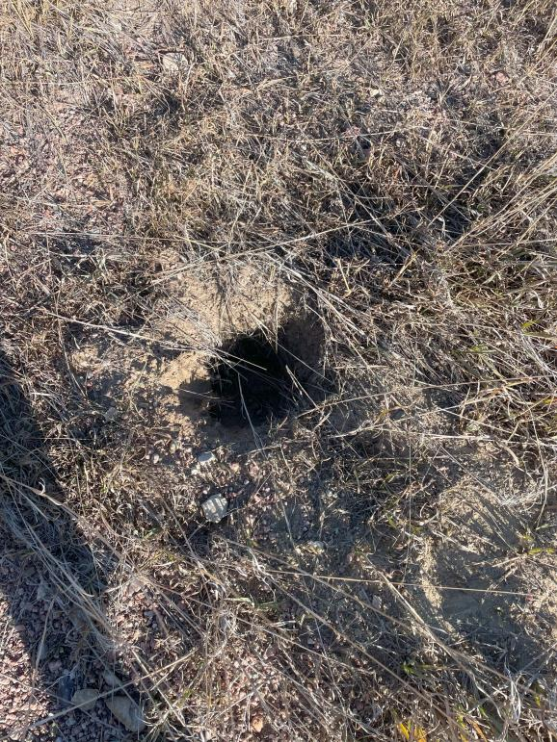
<b>Client Name:</b> Platte River Power Authority		<b>Site Location:</b> Rawhide Station, Wellington, CO	<b>Project No.</b> 60643633
<b>Photo No.</b> <b>2</b>	<b>Date:</b> 12/3/24

<b>Direction Photo Taken:</b>  Birds-eye			
<b>Description:</b>  <u>Location:</u> East slope of Cell 1  Large animal burrow (estimated 6 to 8 inches in diameter)

- Two larger animal burrows (6- to 8-inch diameter) were observed on the east slope and north slope of Cell 1. There does not appear to be an increase in larger burrows from the previous inspection. However, it is recommended that this be monitored and if the numbers of burrows proliferate, removal steps may be required.

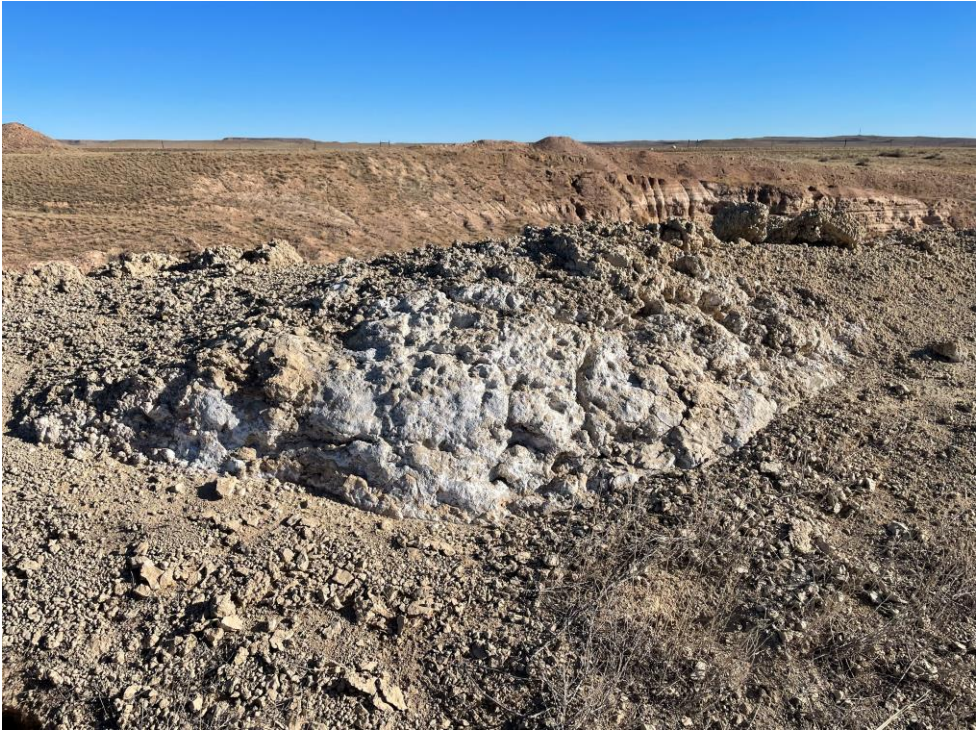
<b>Client Name:</b> Platte River Power Authority		<b>Site Location:</b> Rawhide Station, Wellington, CO	<b>Project No.</b> 60643633
<b>Photo No.</b> <b>3</b>	<b>Date:</b> 12/3/24

<b>Direction Photo Taken:</b>  North			
<b>Description:</b>  <u>Location:</u> North of access road on east side of Cell 1  Exposed ash on North side of road outside cell.

- Remove rabbit brush from the north end of Cell 1.
- Perform periodic cleanout of the two culverts just south of Cells 1 and 2.
- Remove ash debris observed in the road berm located on the north end of Cell 1 and place in Cell 2B.

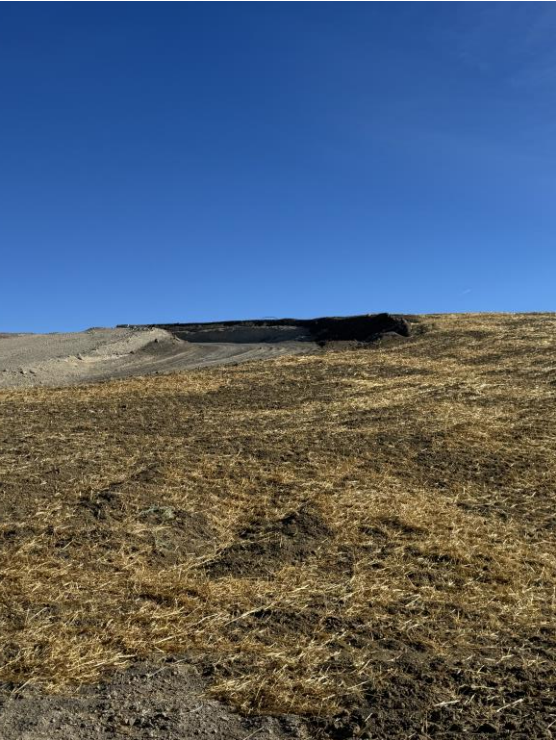
<b>Client Name:</b> Platte River Power Authority		<b>Site Location:</b> Rawhide Station, Wellington, CO	<b>Project No.</b> 60643633
<b>Photo No.</b> <b>4</b>	<b>Date:</b> 12/3/24

perimeter are maintained with gravel surfacing and have storm water drainage swales, preventing direct runoff onto the face of the starter dike. One exception to the gravel access roads observed on cell 1 and cell 2A, was along the former active face of cell 2A. The access road does not contain gravel and is present directly on top of placed Ash (Photo 4 of **Attachment 8**).

<b>Direction Photo Taken:</b>  East			
<b>Description:</b>  <u>Location:</u> Access road on Cell 2A cutting into Cell. New seeding on cover.

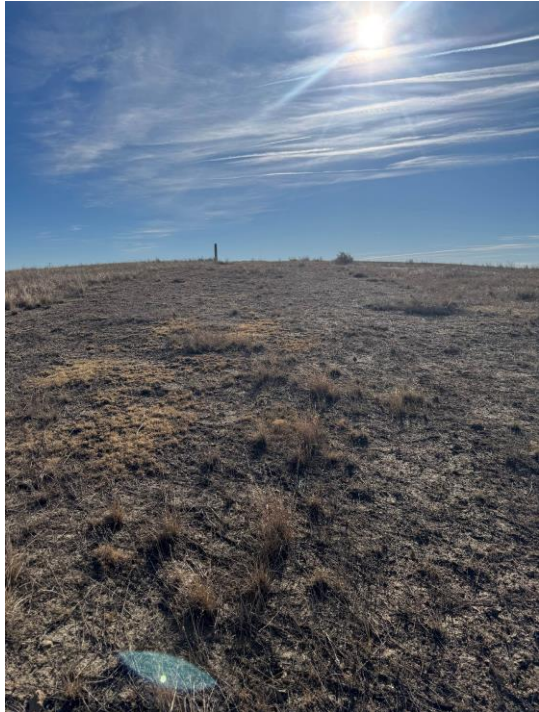
<b>Client Name:</b> Platte River Power Authority		<b>Site Location:</b> Rawhide Station, Wellington, CO	<b>Project No.</b> 60643633
<b>Photo No.</b> <b>5</b>	<b>Date:</b> 12/3/24

- There are a few small areas with current erosion concerns stemming from the sparse vegetation. Sparse vegetation was noted 800 feet north of PRS-02 midway up the east slope of Cell 1. Additionally, thin vegetative cover was observed on the west face of cell 1 approximately 1,000 feet north of the completed cell 2B (Photo 5 of Attachment 8) and on the slopes directly above the new protective cover of Cell 2B across from the sump (Photo 6 of Attachment 8). The sparse vegetation above the protective cover is causing small erosion rills to form in the protective cover (Photo 6 of Attachment 8).

<b>Direction Photo Taken:</b> Southeast			
<b>Description:</b>  <u>Location:</u> Thinning vegetation on northwest side of Cell 1

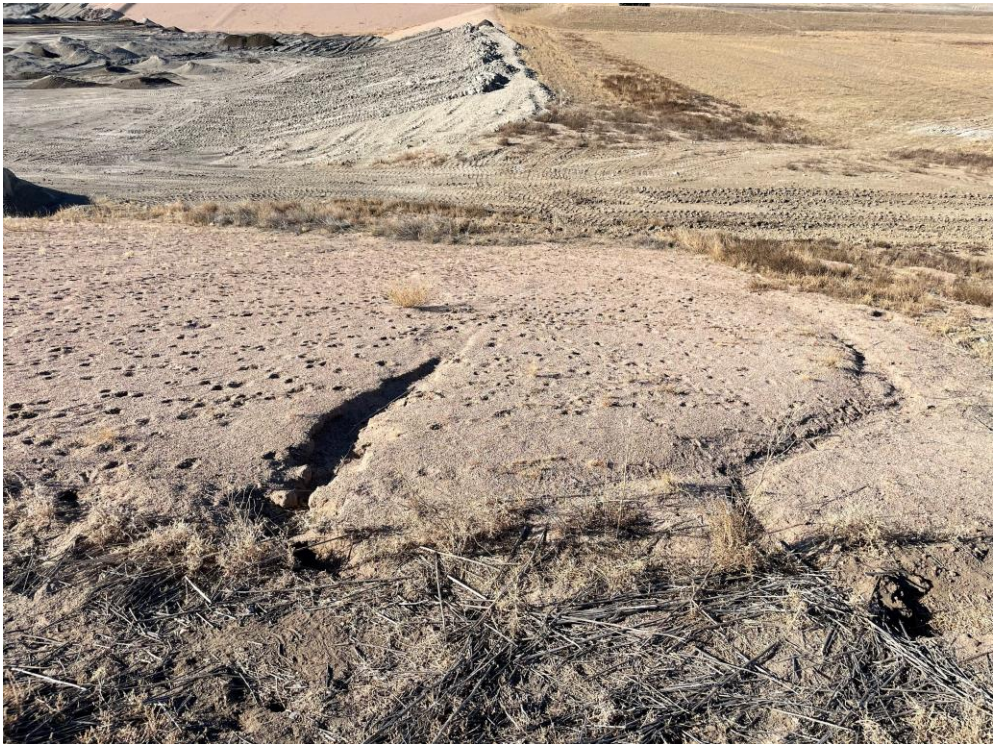
<b>Client Name:</b> Platte River Power Authority		<b>Site Location:</b> Rawhide Station, Wellington, CO	<b>Project No.</b> 60643633
<b>Photo No.</b> <b>6</b>	<b>Date:</b> 12/3/24

<b>Direction Photo Taken:</b> West			
<b>Description:</b>  <u>Location:</u> Cell 2B  Thin vegetation and erosion rills forming in protective cover of Cell 2B

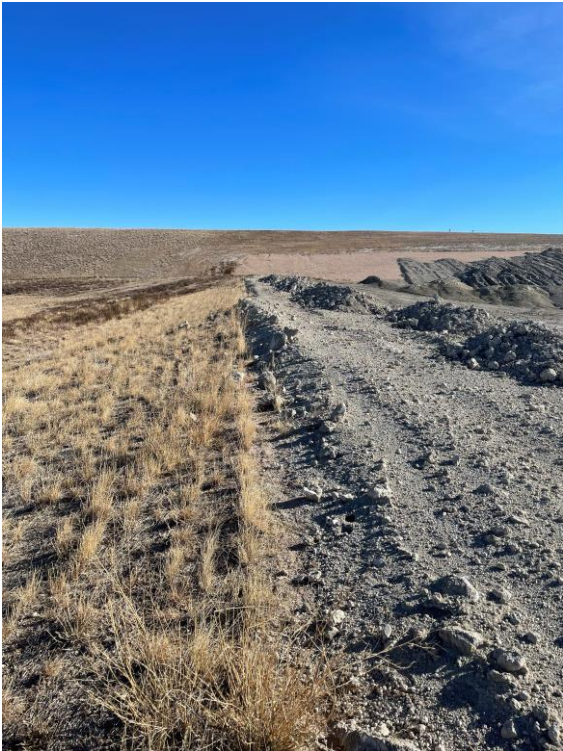
<b>Client Name:</b> Platte River Power Authority		<b>Site Location:</b> Rawhide Station, Wellington, CO	<b>Project No.</b> 60643633
<b>Photo No.</b> <b>8</b>	<b>Date:</b> 12/17/24

- Ash was observed to be pushed outside the extent of the protective cover along the northern slope (Photo 8 of Attachment 8) and the west slope (Photo 9 of Attachment 8) on cell 2B.

<b>Direction Photo Taken:</b> East			
<b>Description:</b>  <u>Location:</u> Ash pushed outside of protective cover along northern slope of Cell 2B

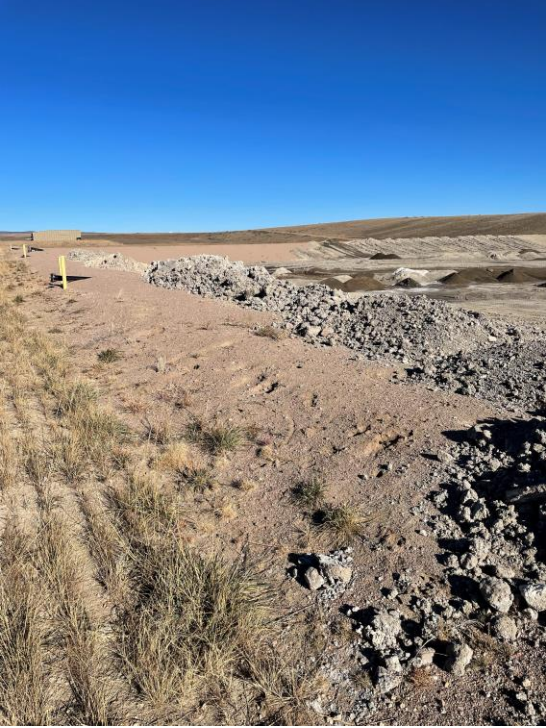
<b>Client Name:</b> Platte River Power Authority		<b>Site Location:</b> Rawhide Station, Wellington, CO	<b>Project No.:</b> 60643633
<b>Photo No.:</b> <b>9</b>	<b>Date:</b> 12/3/24

<b>Direction Photo Taken:</b>  North			
<b>Description:</b>  <u>Location:</u> Ash pushed outside of protective cover along western slope of Cell 2B

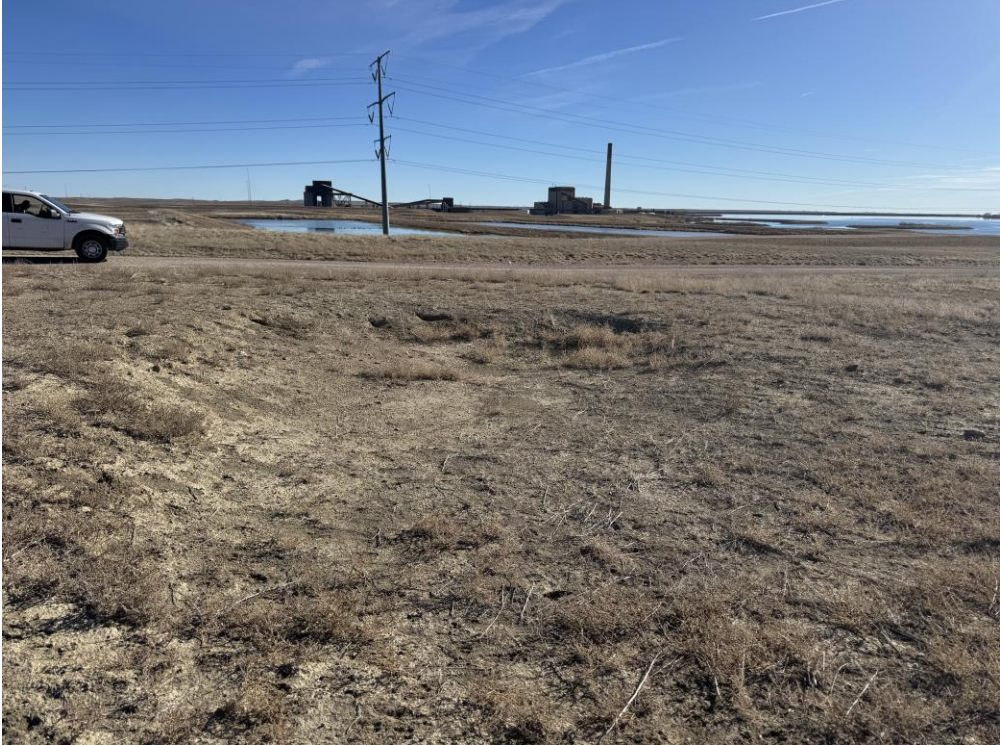
<b>Client Name:</b> Platte River Power Authority		<b>Site Location:</b> Rawhide Station, Wellington, CO	<b>Project No.:</b> 60643633
<b>Photo No.:</b> <b>10</b>	<b>Date:</b> 12/3/24

- A small depression (1-2 feet in depth by approximately 10 foot in diameter) was observed on top of cell 2A approximately 500 feet south of the northeast corner of the former active face (Photo 10 of Attachment 8).

<b>Direction Photo Taken:</b>  East			
<b>Description:</b>  <u>Location:</u> Depression in Cell 2a, approximately 500 ft south of northeast corner of former active face

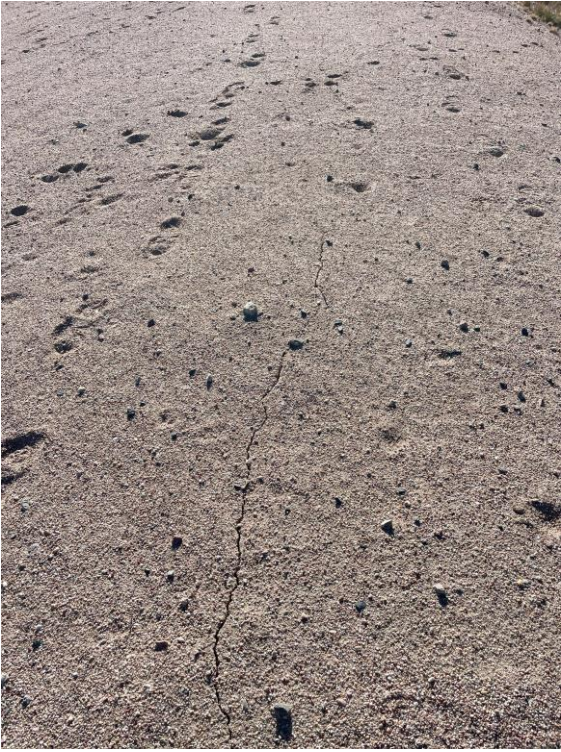
<b>Client Name:</b> Platte River Power Authority		<b>Site Location:</b> Rawhide Station, Wellington, CO	<b>Project No.</b> 60643633
<b>Photo No.</b> <b>11</b>	<b>Date:</b> 12/3/24

- A small surface crack was observed in the protective cover along the west facing berm. Crack was approximately 0.5 cm wide by 3 feet long (Photo 11 of Attachment 8).

<b>Direction Photo Taken:</b>  Birds-eye			
<b>Description:</b>  <u>Location:</u>  Small surface crack in protective cover along western berm

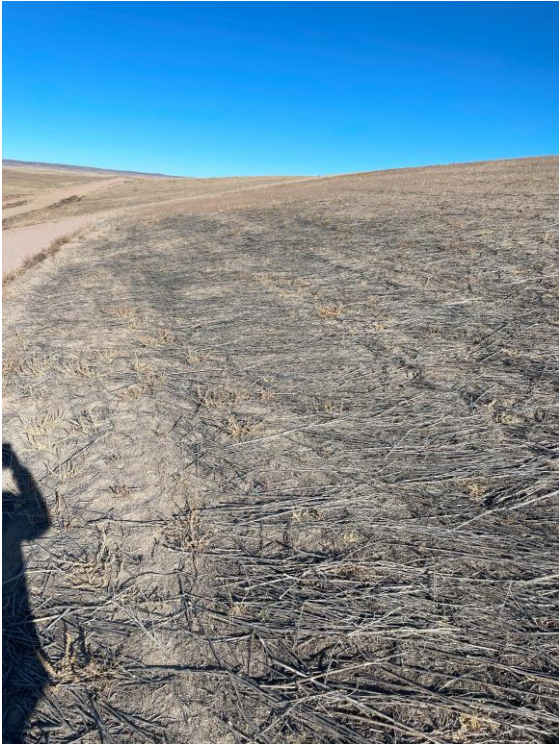
<b>Client Name:</b> Platte River Power Authority		<b>Site Location:</b> Rawhide Station, Wellington, CO	<b>Project No.</b> 60643633
<b>Photo No.</b> <b>13</b>	<b>Date:</b> 12/3/24

<b>Direction Photo Taken:</b>  North			
<b>Description:</b>  <u>Location:</u>  Sparse vegetation on western slope of Cell 1

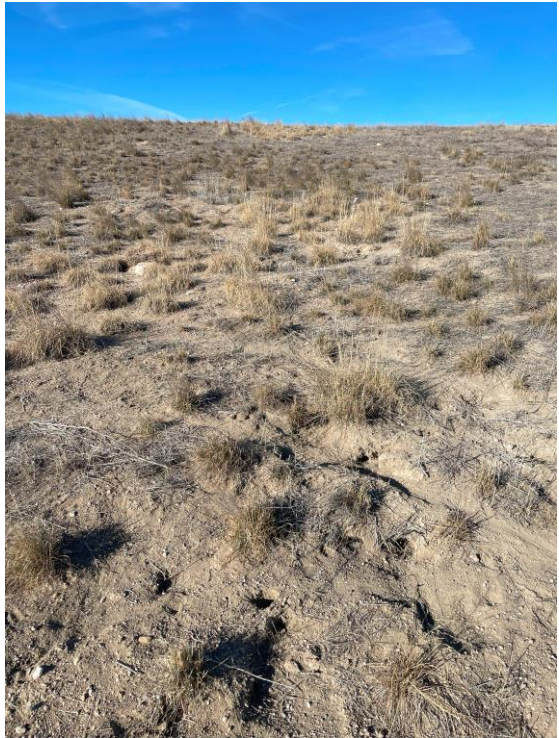
<b>Client Name:</b> Platte River Power Authority		<b>Site Location:</b> Rawhide Station, Wellington, CO	<b>Project No.</b> 60643633
<b>Photo No.</b> <b>14</b>	<b>Date:</b> 12/3/24

<b>Direction Photo Taken:</b>  West			
<b>Description:</b>  <u>Location:</u>  Small animal burrow and thin vegetation on east face of Cell 1 north of PRS Ponds

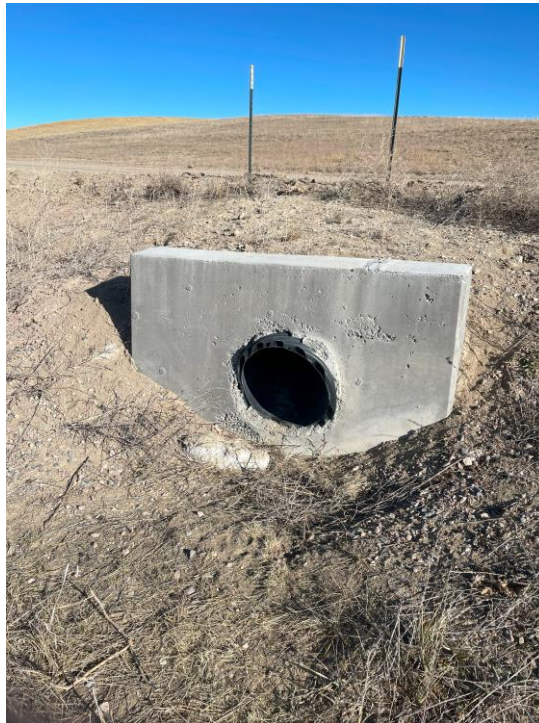
- Stormwater culverts were inspected and considered to be in good working conditions (Photos 12 and 13 of **Attachment 8**).

Location:  
Stormwater drainage culvert
