Submitted to:  
Platte River Power Authority  
Ft. Collins, CO

Submitted by:  
AECOM  
Ft. Collins, CO  
60775025  
January 2026

## Platte River Power Authority Rawhide Station

### Annual Ash Monofill Inspection Report – 2025

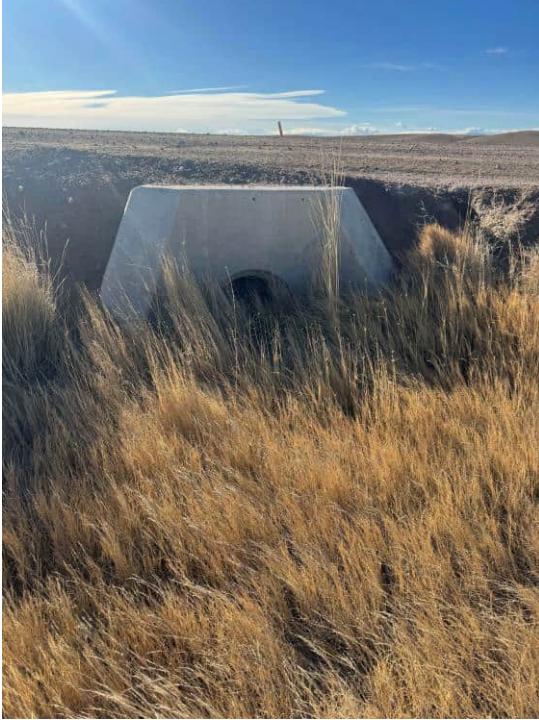
<b>Client Name:</b> Platte River Power Authority		<b>Site Location:</b> Rawhide Station, Wellington, CO	<b>Project No.</b> 60775025
<b>Photo No.</b> <b>1</b>	<b>Date:</b> 12/10/25		
<b>Direction Photo Taken:</b>  South

- Stormwater culverts were inspected and considered to be in good working conditions (Photos 1 and 2 of **Attachment 8**). The outfall side of the stormwater culvert near monitoring well ASH-03 is half buried in sediment and could be cleaned out.

<b>Description:</b>  <u>Location:</u> Southeast corner of Cell 2A (East).  16-inch concrete stormwater drainage culvert.

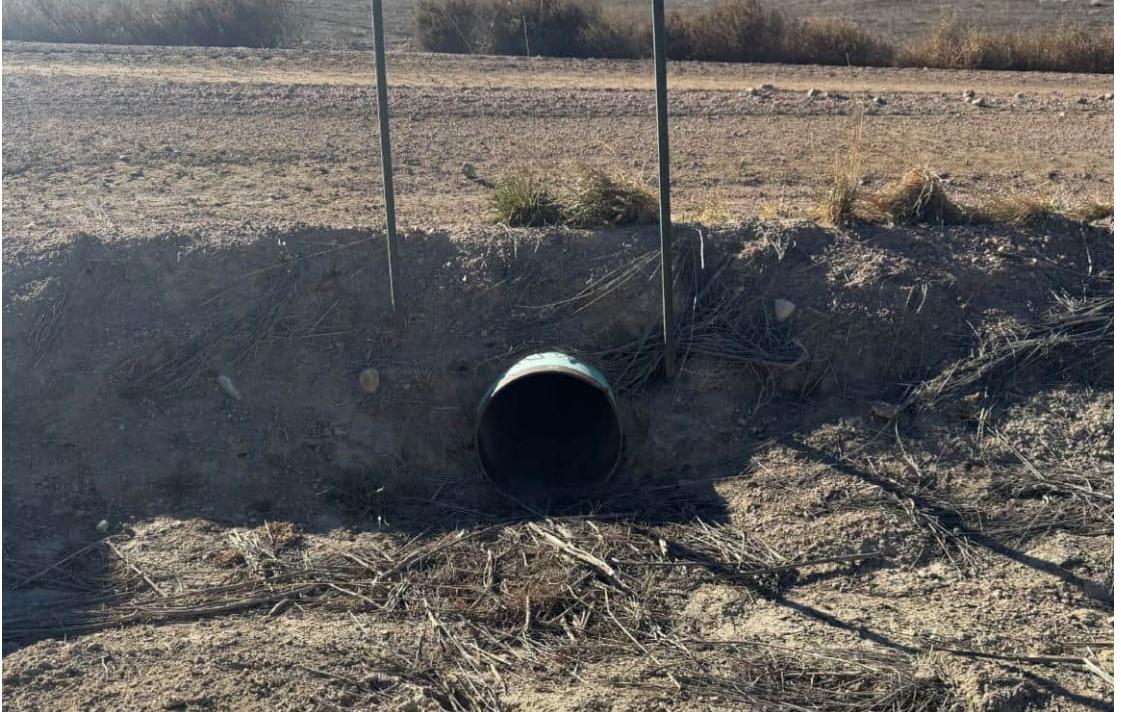
<b>Client Name:</b> Platte River Power Authority		<b>Site Location:</b> Rawhide Station, Wellington, CO	<b>Project No.</b> 60775025
<b>Photo No.</b> <b>2</b>	<b>Date:</b> 12/10/25		
<b>Direction Photo Taken:</b>  Southwest

<b>Description:</b>  <u>Location:</u> Southern corner of completed Cell 2.  steel stormwater drainage culvert.

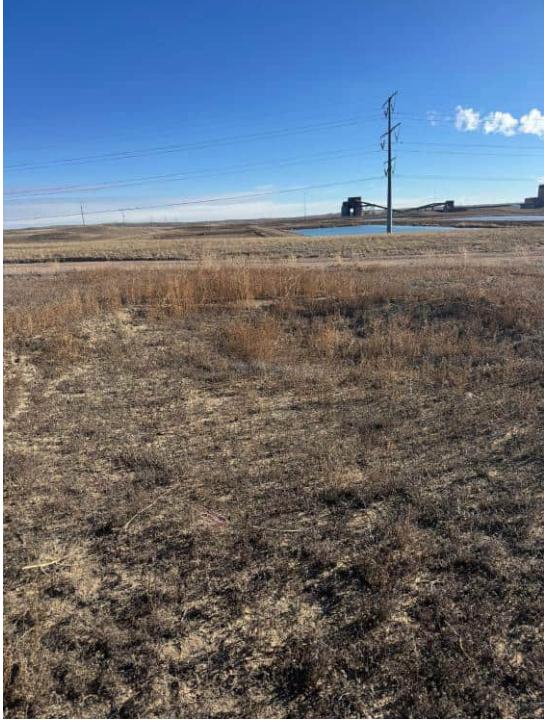
- Ash was observed outside the limit of the landfill on the northern edge (Photo 20 of **Attachment 8**).
- A small depression (1-2 feet in depth by approximately 10 foot in diameter) was observed on top of Cell 2A approximately 500 feet south of the northeast corner of the former active face (Photo 3 of **Attachment 8**).

<b>Client Name:</b> Platte River Power Authority		<b>Site Location:</b> Rawhide Station, Wellington, CO	<b>Project No.</b> 60775025
<b>Photo No.</b> <b>3</b>	<b>Date:</b> 12/10/25		
<b>Direction Photo Taken:</b>  East			
<b>Description:</b>  <u>Location:</u> Eastern side of Cell 2A (West).  Approximately 2 feet deep, square shaped depression in the vegetation cover.

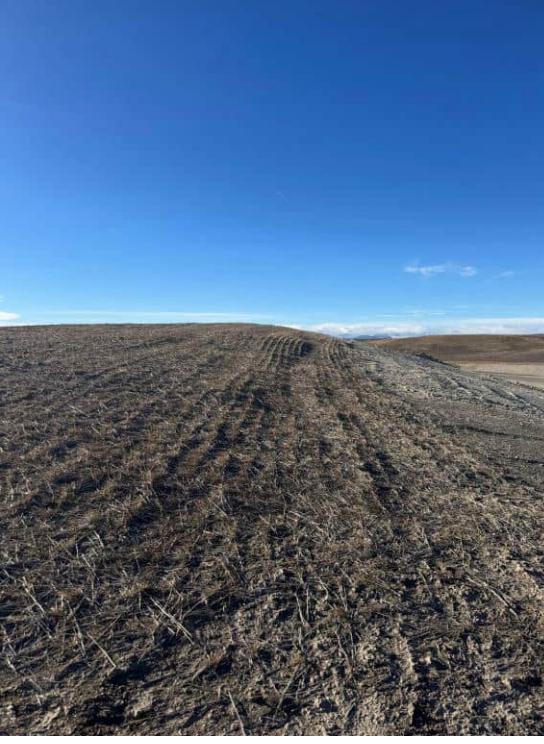
<b>Client Name:</b> Platte River Power Authority		<b>Site Location:</b> Rawhide Station, Wellington, CO	<b>Project No.</b> 60775025
<b>Photo No.</b> <b>4</b>	<b>Date:</b> 12/10/25		
<b>Direction Photo Taken:</b>  West			
<b>Description:</b>  <u>Location:</u> Western side of Completed Cell 1 (West).  Sparse vegetation growth. Apparent reseeding took place.

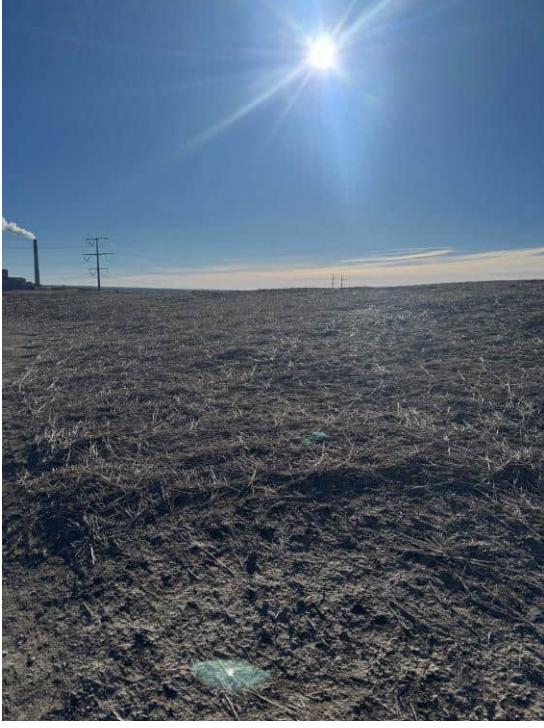
<b>Client Name:</b> Platte River Power Authority		<b>Site Location:</b> Rawhide Station, Wellington, CO	<b>Project No.</b> 60775025
<b>Photo No.</b> <b>5</b>	<b>Date:</b> 12/10/25

<b>Direction Photo Taken:</b>	Southeast		
<b>Description:</b> <u>Location:</u> Top of completed Cell 1 (West). Sparse vegetation in section running east/west across top of cell 1.

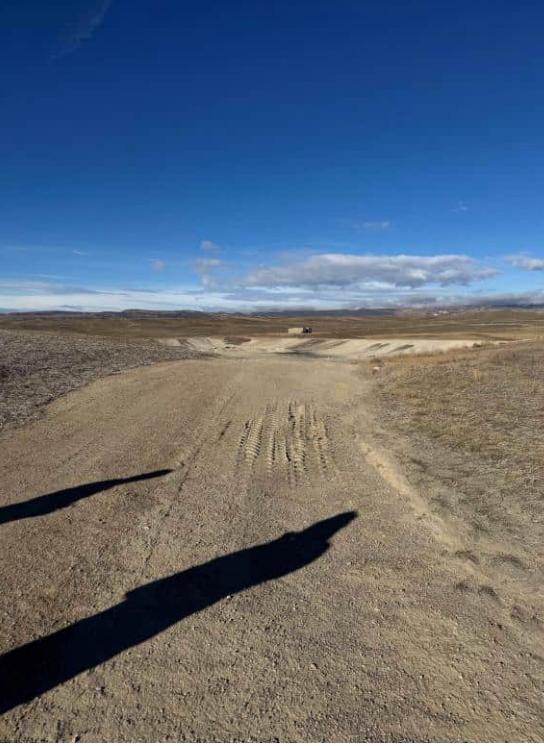
<b>Client Name:</b> Platte River Power Authority		<b>Site Location:</b> Rawhide Station, Wellington, CO	<b>Project No.</b> 60775025
<b>Photo No.</b> <b>6</b>	<b>Date:</b> 12/10/25

- Access roads over the starter dikes and around the monofill perimeter are maintained with gravel surfacing and have storm water drainage swales, preventing direct runoff onto the face of the starter dike. One exception to the gravel access roads observed on Cell 1 and Cell 2A running towards the corner of Cell 2B. The access road does not contain gravel or protective cover and is present directly on top of placed ash (Photos 6-9 of **Attachment 8**).

<b>Direction Photo Taken:</b>	Northwest		
<b>Description:</b> <u>Location:</u> Roadway between Cell 2A and completed Cell 1 (West) running towards cell 2B. No protective cover or gravel, placed directly on ash.

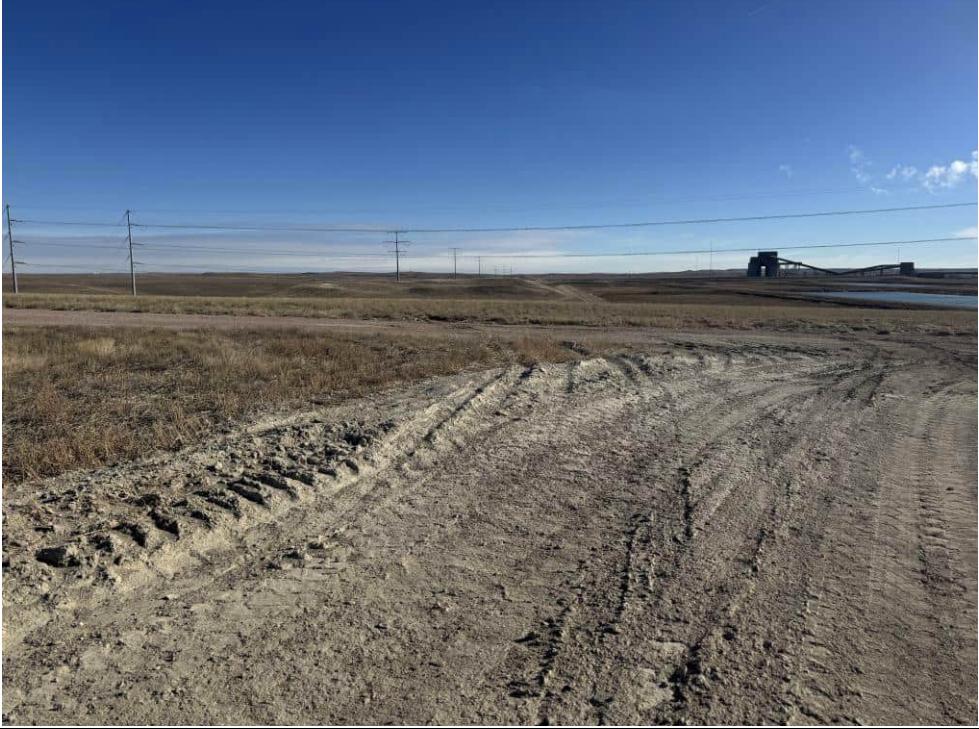
<b>Client Name:</b> Platte River Power Authority		<b>Site Location:</b> Rawhide Station, Wellington, CO	<b>Project No.</b> 60775025
<b>Photo No.</b> <b>7</b>	<b>Date:</b> 12/10/25

<b>Direction Photo Taken:</b>  Southeast			
<b>Description:</b>  <u>Location:</u> Roadway between Cell 2A and completed Cell 1 (West).  Tracks from haul trucks within the corner of the vegetation. Ash at surface.

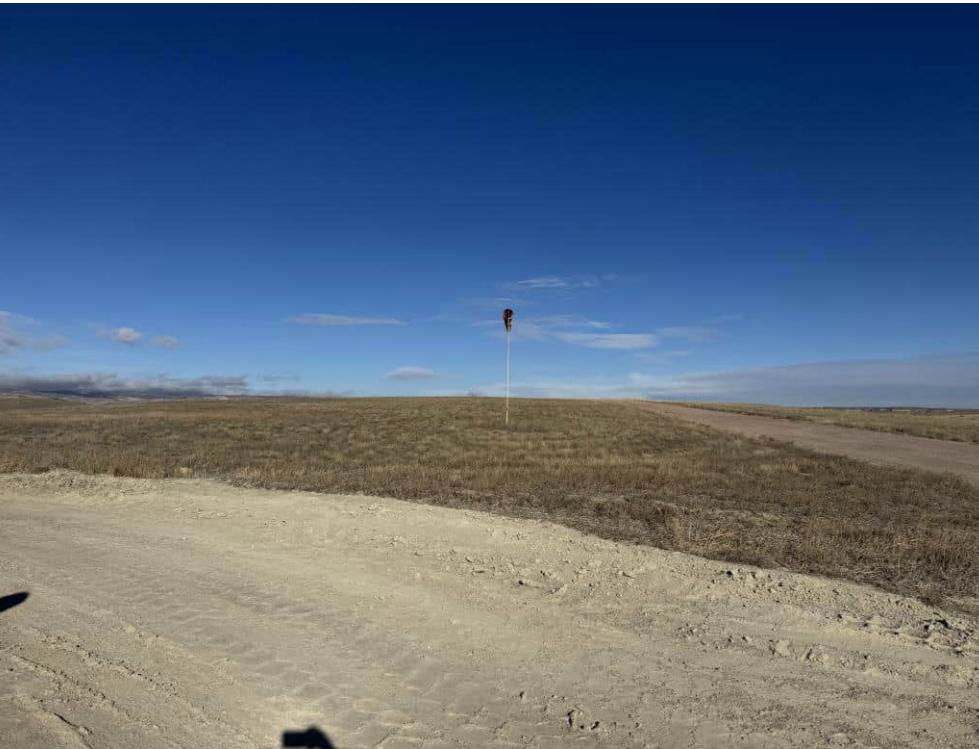
<b>Client Name:</b> Platte River Power Authority		<b>Site Location:</b> Rawhide Station, Wellington, CO	<b>Project No.</b> 60775025
<b>Photo No.</b> <b>8</b>	<b>Date:</b> 12/10/25

<b>Direction Photo Taken:</b>  North			
<b>Description:</b>  <u>Location:</u> Roadway between Cell 2A and completed Cell 1 (West).  Ash at surface from haul trucks.

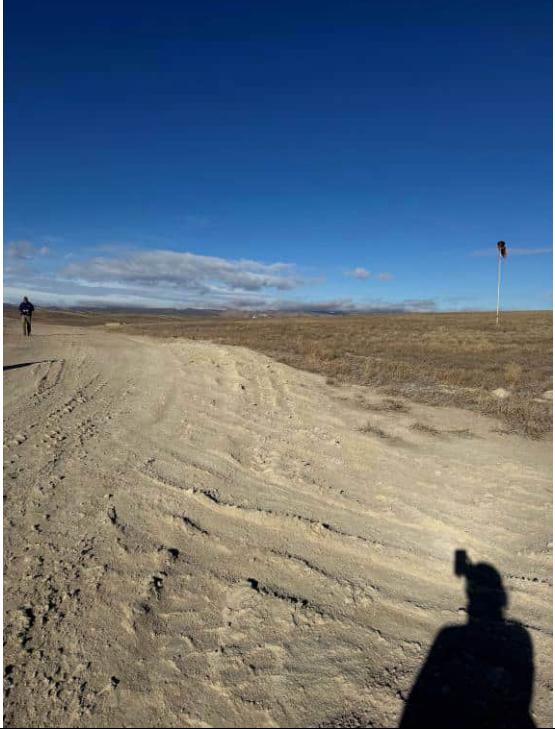
<b>Client Name:</b> Platte River Power Authority		<b>Site Location:</b> Rawhide Station, Wellington, CO	<b>Project No.</b> 60775025
<b>Photo No.</b> <b>9</b>	<b>Date:</b> 12/10/25

<b>Direction Photo Taken:</b>  Northwest			
<b>Description:</b>  <u>Location:</u> Roadway between Cell 2A and completed Cell 1 (West).  Ash at surface from Haul trucks.

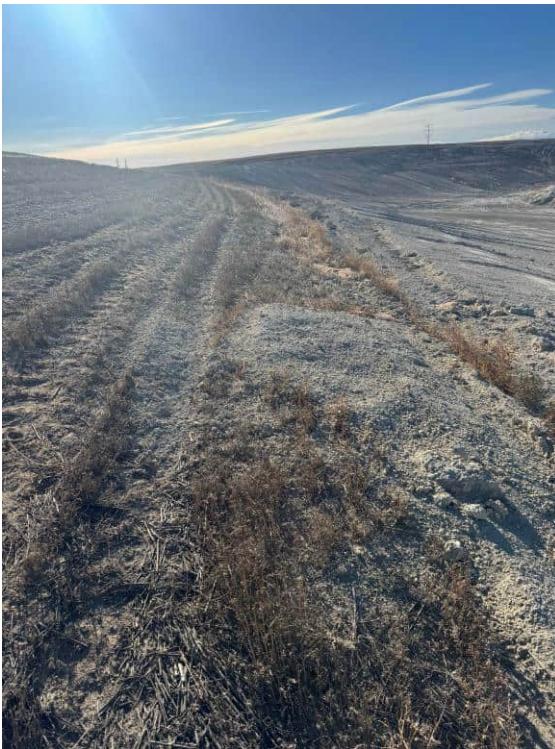
<b>Client Name:</b> Platte River Power Authority		<b>Site Location:</b> Rawhide Station, Wellington, CO	<b>Project No.</b> 60775025
<b>Photo No.</b> <b>10</b>	<b>Date:</b> 12/10/25

- Ash was observed to be pushed outside the extent of the protective cover along the western slope of Cell 1 (Photo 10 of **Attachment 8**) and northern slope of Cell 2B (Photo 11 of **Attachment 8**).

<b>Direction Photo Taken:</b>  South			
<b>Description:</b>  <u>Location:</u> Northeast corner of Cell 2B.  Small amount of ash outside footprint of lined cell 2B. Ash on top of protective cover of cell 1.

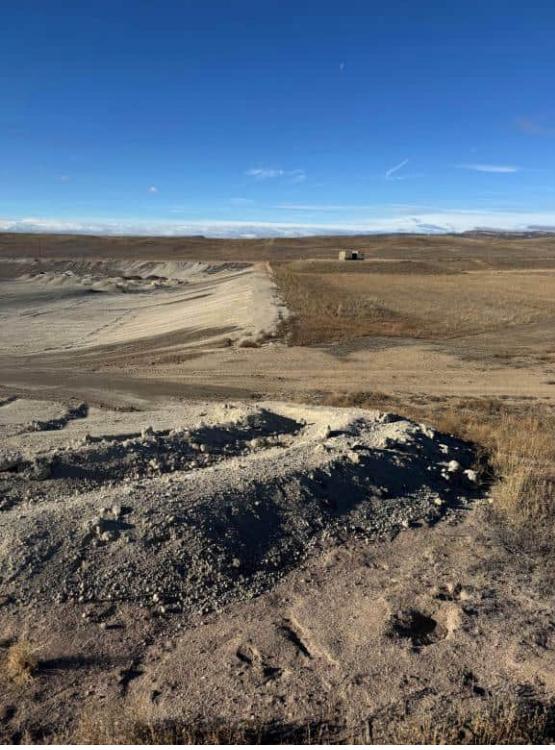
<b>Client Name:</b> Platte River Power Authority		<b>Site Location:</b> Rawhide Station, Wellington, CO	<b>Project No.</b> 60775025
<b>Photo No.</b> <b>11</b>	<b>Date:</b> 12/10/25		
<b>Direction Photo Taken:</b>			
West			
<b>Description:</b>			
<u>Location:</u> Northeast corner of cell 2B.  Ash placement to edge and slightly outside of lined portion of cell.

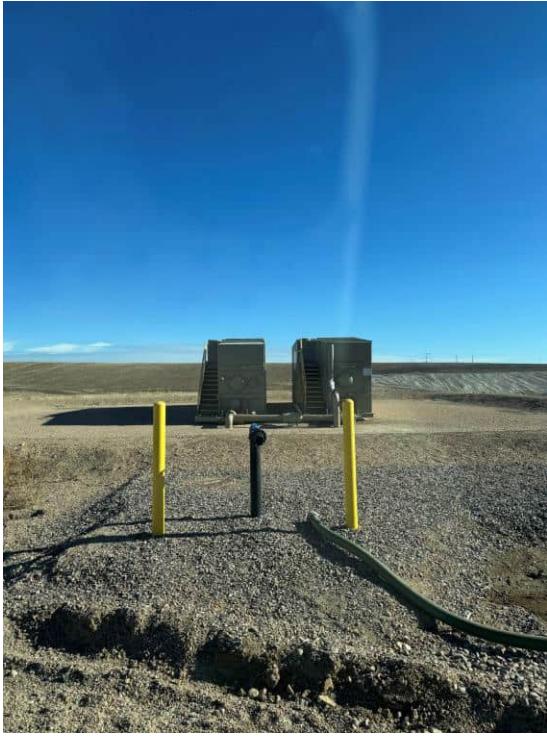
<b>Client Name:</b> Platte River Power Authority		<b>Site Location:</b> Rawhide Station, Wellington, CO	<b>Project No.</b> 60775025
<b>Photo No.</b> <b>12</b>	<b>Date:</b> 12/10/25		
<b>Direction Photo Taken:</b>			
East

<b>Description:</b>			
<u>Location:</u> north end of cell 2B.  Leachate collection system tanks and loadout piping.

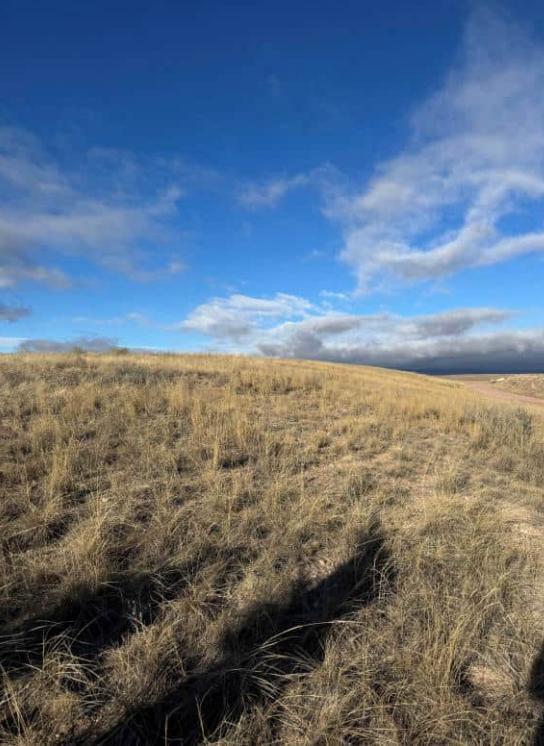
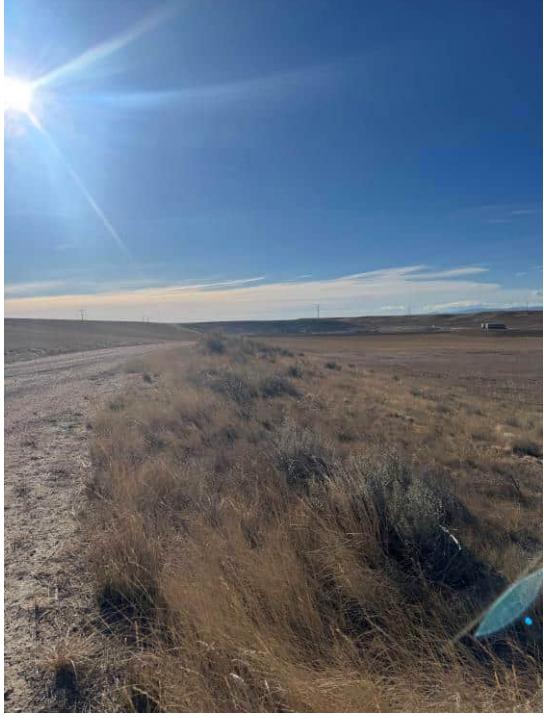
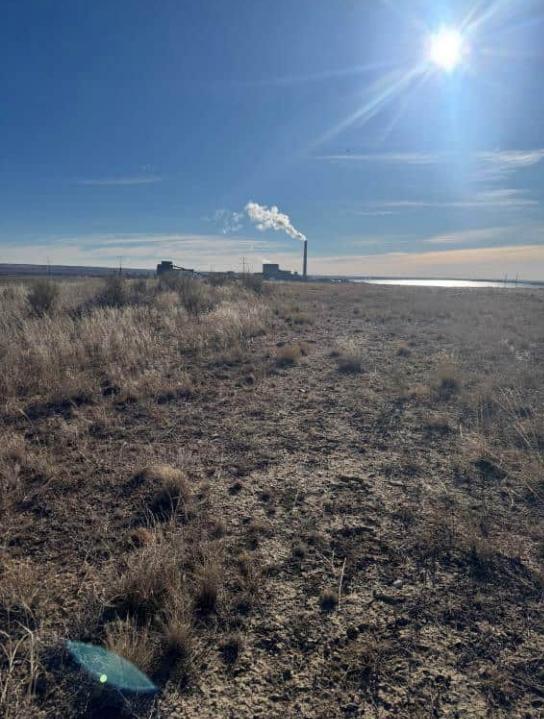
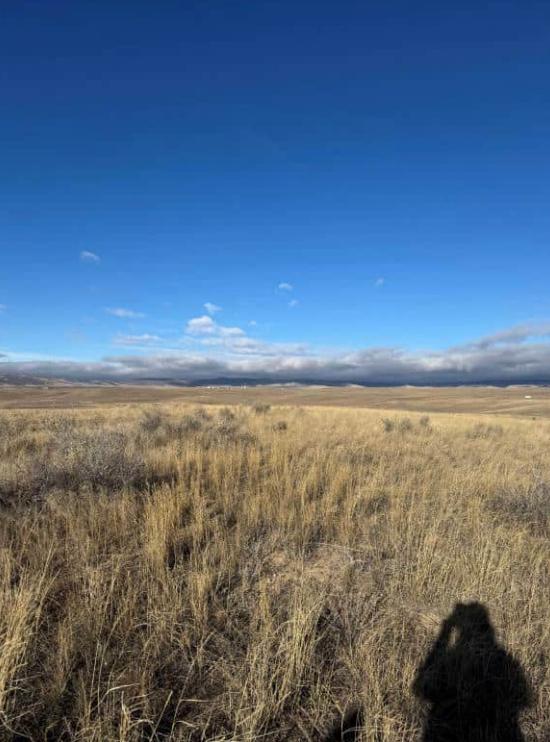
- Rabbitbrush plants were observed at the north end of the cover to Cell 1 scattered within vegetative grasses (Photos 16, 21, 22, 24 of **Attachment 8**). Brush size averages 2-3 feet in diameter.

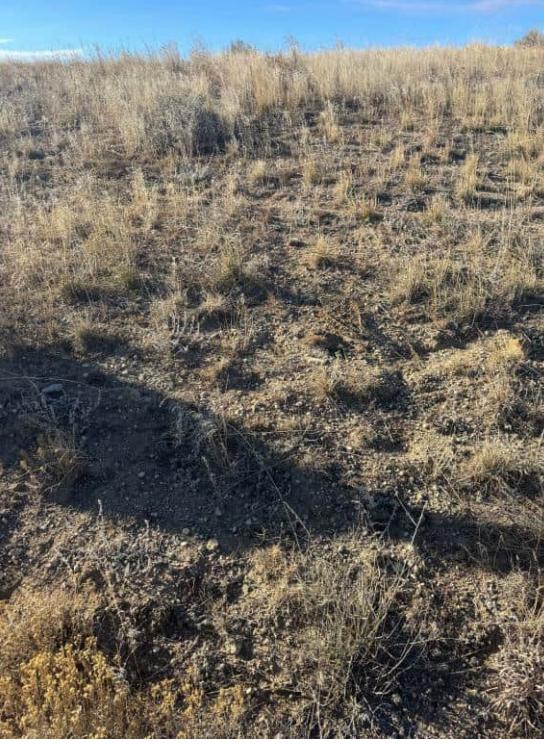
<b>Client Name:</b> Platte River Power Authority		<b>Site Location:</b> Rawhide Station, Wellington, CO	<b>Project No.</b> 60775025
<b>Photo No.</b> <b>18</b>	<b>Date:</b> 12/10/25		
<b>Direction Photo Taken:</b>  West

- There are a few small areas with current erosion stemming from the sparse vegetation. Sparse vegetation was noted 800 feet north of PRS-02 midway up the east slope of Cell 1 (Photo 18 of **Attachment 8**). Additionally, thin vegetative cover was observed on the slopes directly above the new protective cover of Cell 2B across from the sump (Photo 4 of **Attachment 8**). Thin vegetation is also present along the north end of Cell 1 running in an east/west orientation and appears to be an old roadway (Photos 5, 22, 25 of **Attachment 8**). Sparse vegetation on the east face of the north end of Cell 1 forms minor erosional features between grass clumps (Photo 28 of **Attachment 8**).

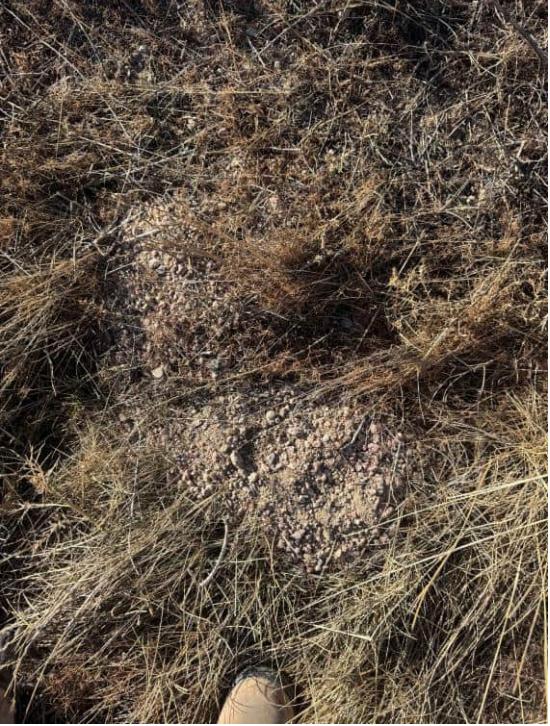
<b>Client Name:</b> Platte River Power Authority		<b>Site Location:</b> Rawhide Station, Wellington, CO	<b>Project No.</b> 60775025
<b>Photo No.</b> <b>19</b>	<b>Date:</b> 12/10/25		
<b>Direction Photo Taken:</b>  Birds-eye view

- Additionally, small amounts of exposed ash were observed near the ditch and access road on the east side of Cell 1, approximately 1,000 feet north of the PRS Ponds (Photos 19 and 29 of **Attachment 8**).

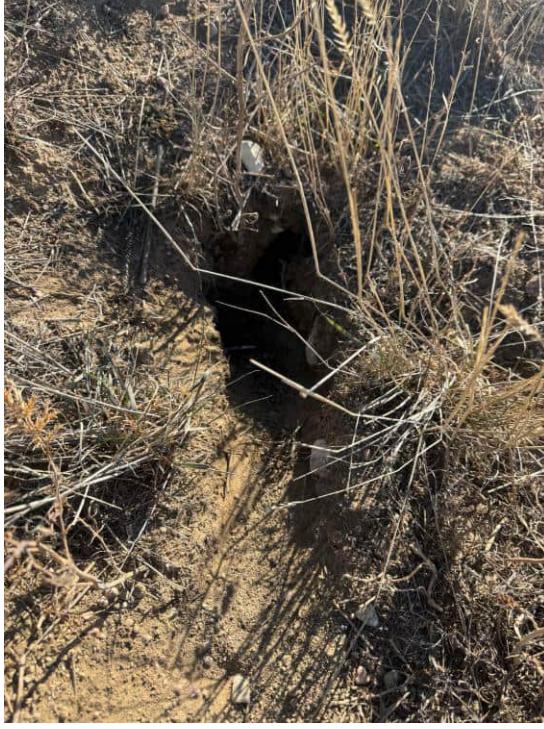
<b>Client Name:</b> Platte River Power Authority		<b>Site Location:</b> Rawhide Station, Wellington, CO	<b>Project No.</b> 60775025
<b>Photo No.</b> <b>32</b>	<b>Date:</b> 12/10/25		
<b>Direction Photo Taken:</b>  Birds-eye view

- The starter dike at Cell 1 and Cell 2 appeared to be in good condition with occasional small animal burrows (1 to 2-inch diameter) in the upper 8 to 12 inches of the ground surface in isolated areas. The cover slopes of Cell 1 and Cell 2 appear to be in good condition with occasional animal burrows in isolated areas (Photo 1 of **Attachment 8**).
- One large burrow (6- to 8-inch diameter) was observed on the east slope of Cell 1, approximately 150 feet west of the access road and approximately 150 feet south of monitoring well PRS-01 (Photo 34 of **Attachment 8**). A second large animal burrow (6-8 inches in diameter) was observed at the north end of Cell 1. A third larger animal burrow was observed on the west side of Cell 1, approximately half the distance between piezometers PZ-2 and PZ-3 and 100 feet up the slope of the cell (Photo 32 and 33 of **Attachment 8**).

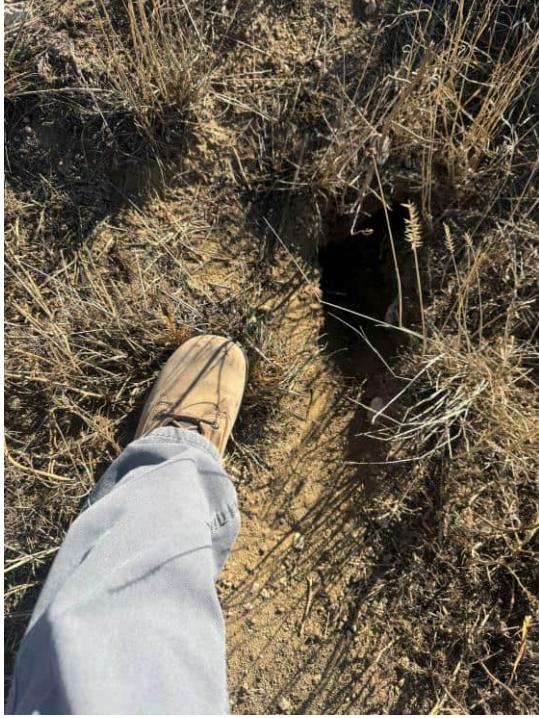
<b>Client Name:</b> Platte River Power Authority		<b>Site Location:</b> Rawhide Station, Wellington, CO	<b>Project No.</b> 60775025
<b>Photo No.</b> <b>33</b>	<b>Date:</b> 12/10/25		
<b>Direction Photo Taken:</b>  Birds-eye view			
<b>Description:</b>  <u>Location:</u> Middle of completed Cell 1 (West).  The animal burrow pictured above with a foot as size reference.

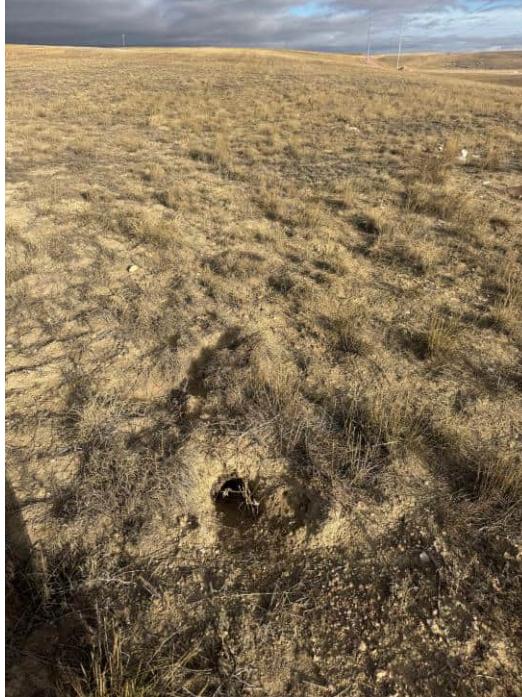
<b>Client Name:</b> Platte River Power Authority		<b>Site Location:</b> Rawhide Station, Wellington, CO	<b>Project No.</b> 60775025
<b>Photo No.</b> <b>34</b>	<b>Date:</b> 12/10/25		
<b>Direction Photo Taken:</b>  North

<b>Description:</b>  <u>Location:</u> South end of cell 1.  The animal burrow.

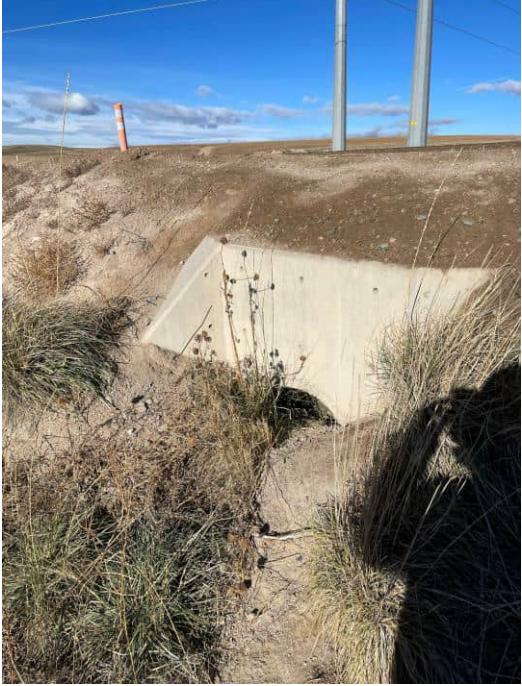
<b>Client Name:</b> Platte River Power Authority		<b>Site Location:</b> Rawhide Station, Wellington, CO	<b>Project No.</b> 60775025
<b>Photo No.</b> <b>35</b>	<b>Date:</b> 12/10/25		
<b>Direction Photo Taken:</b>  North			
<b>Description:</b>  <u>Location:</u> cell 2A stormwater culvert near monitoring well ASH-03.  Partially covered stormwater outfall pipe.
